Titan Telescoping Flagpole “Interlocking Sleeve Replacement” Instructions

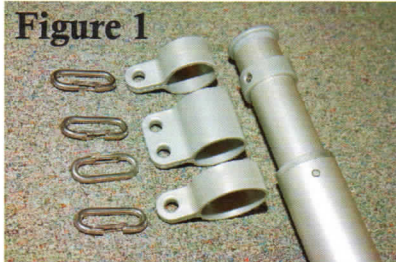
To begin collapse pole and place on flat working surface (tabletop or workbench). Remove all accessories and hardware (ball top, flag & flag harnesses). **Figure 1**

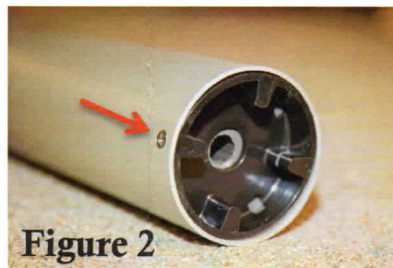
Figure 2

Remove black cap and foam cushion from bottom of pole by taking out two screws. **Figure 2 & 3**

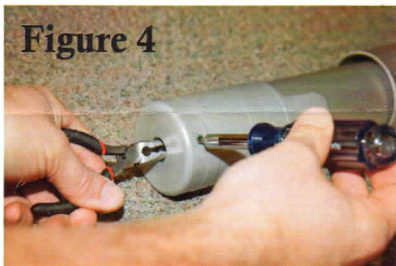
Figure 4

Slide tube sections out through bottom of pole to expose **BIS** (Bottom Interlocking Sleeve). With needle-nose pliers and screwdriver, remove screw and pin. Remove **BIS**. REPEAT to replace additional failed **BIS** parts as necessary. **Figure 4,5 & 6**

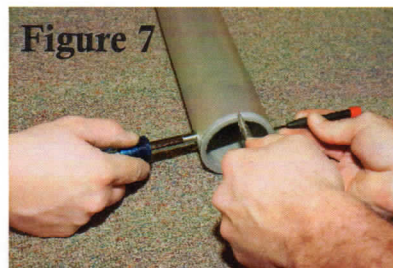
Figure 7

To replace **TIS** (Top Interlocking Sleeve) depress both tabs and slide out failed part. Press in new **TIS**. **Figure 7, 8 & 9**
